Coastal Erosion and Flooding Hazards on the North Sea Coast at Thyboron, Denmark

Citation (APA):
Sørensen , P., Sørensen, C. S., Nielsen, P., Ciocan, R., & Knudsen, P. (2016). *Coastal Erosion and Flooding Hazards on the North Sea Coast at Thyboron, Denmark*. Poster session presented at International Coastal Symposium 2016, Sydney, Australia.

COASTAL EROSION AND FLOODING HAZARDS ON THE NORTH SEA COAST AT THYBORON, DENMARK

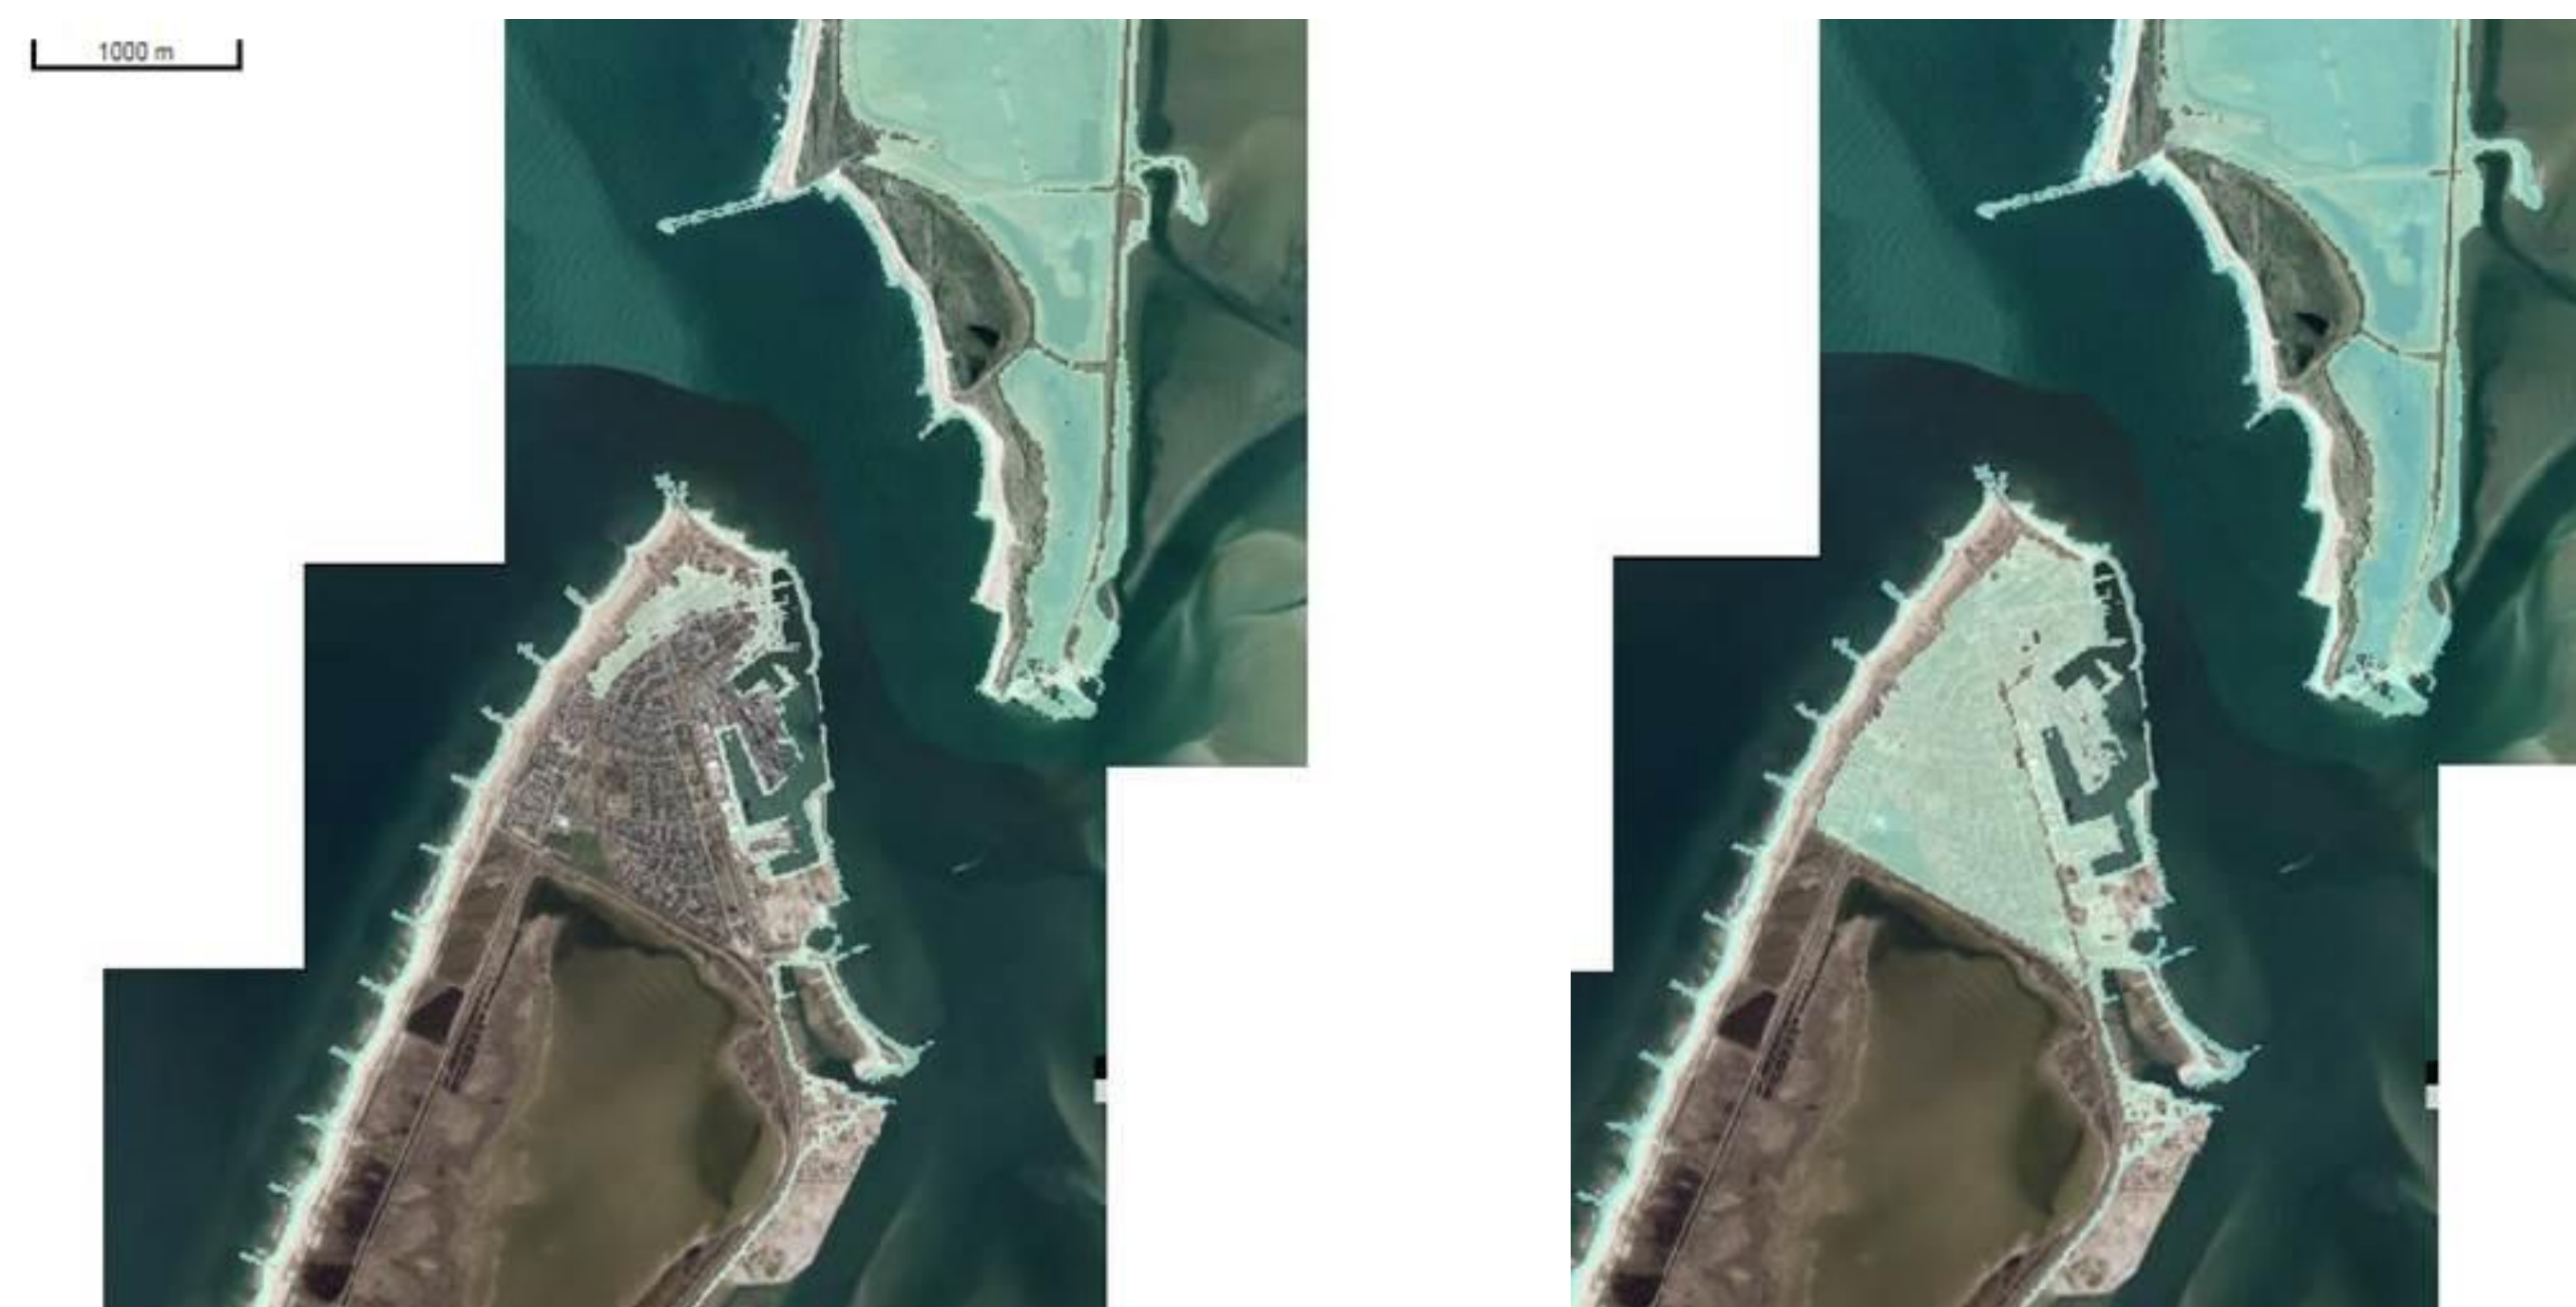
Figure 5. Potential flooding extent from a storm surge at Thyboron Harbor with a return period of 50 years in 2016 (left) and in 2060 including sea level rise and land subsidence.

The cross-sectional area of the channel is out of equilibrium with the tidal prism and increases; leading to more extreme storm surge levels inside the fiord, Figure 4. Furthermore, the town of Thyboron experiences a differentiated net land subsidence of 2-8 mm/y. The increased cross-section, land subsidence and climate changes together will increase the future flood risk in Thyboron significantly, Figure 5.

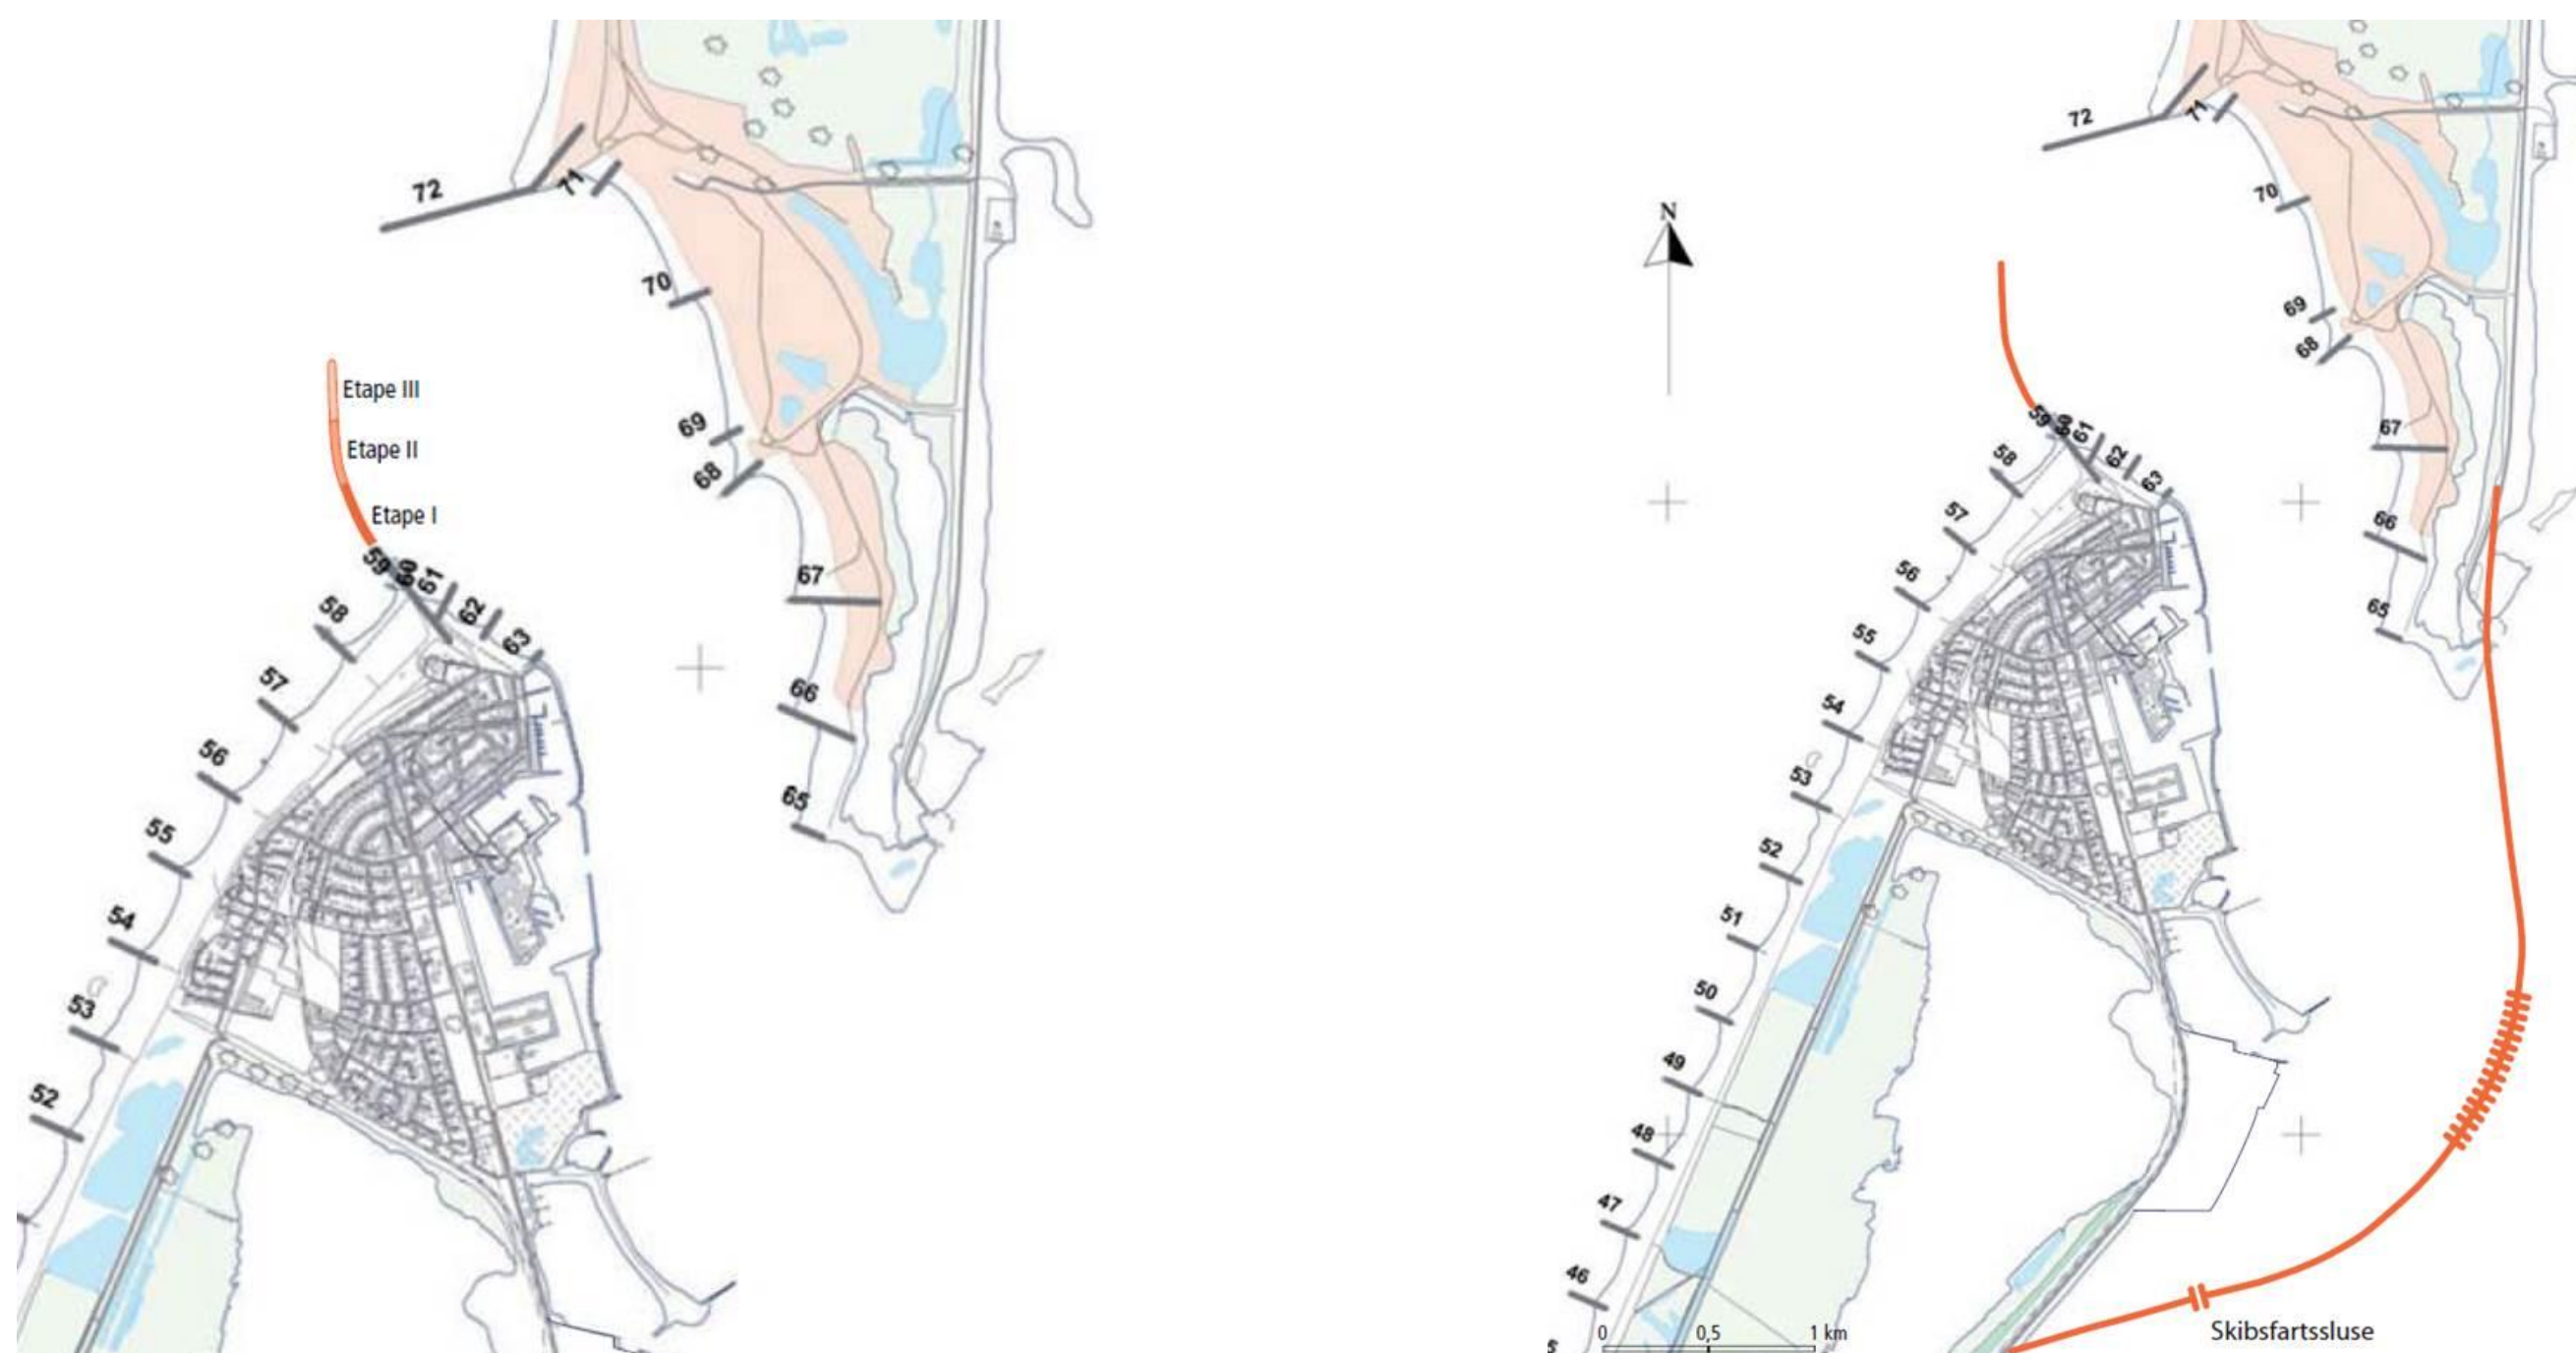
Figure 6. Technically preferred management option: extending a groin to at breakwater (left) and an alternative management option with a sluice.

Eight different options to manage the erosion and flooding hazards in the future have been analyzed. The technically preferred option is to extend of one of the groins to reduce the cross-sectional area to reduce the net erosion rates on the barriers, to limit storm surge water levels, and to makes it easier to enter the navigation channel. A sluice solution has also been analyzed due mainly to environmental issues, Figure 6. A more detailed analysis work is still necessary, however, in order to effectively deal with the combined erosion and flood hazard challenges and to decide upon the optimal solution for the future protection of Thyboron and the Lim Fiord barriers.
